Rimkus Consulting Group, Inc.
203 Bulifants Blvd., Suite A
Williamsburg, VA 23188
(800) 535-1547 Telephone
(757) 229-2886 Facsimile

December 13, 2012

Re: Client: Cameron Crockett
RCG File No: 47601686
Subject: **Report of Findings**

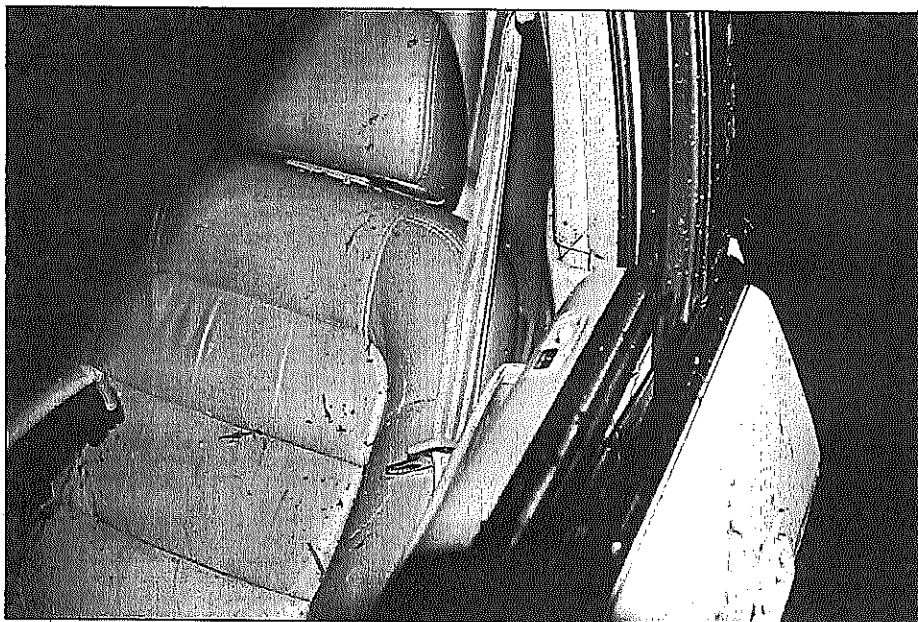
Photographs from the crash scene prior to extricating the passenger show the left (driver) side seatbelt intact (**Photograph 1**). The Honda was inspected on December 10, 2012, at the police impound lot on Leroy Road in Virginia Beach, Virginia. The Honda had severe impact damage on the right side. The roof had been cut off and was resting on top of the vehicle. Both frontal airbags had deployed during the incident.

Photograph 1
Driver's seatbelt after the collision.

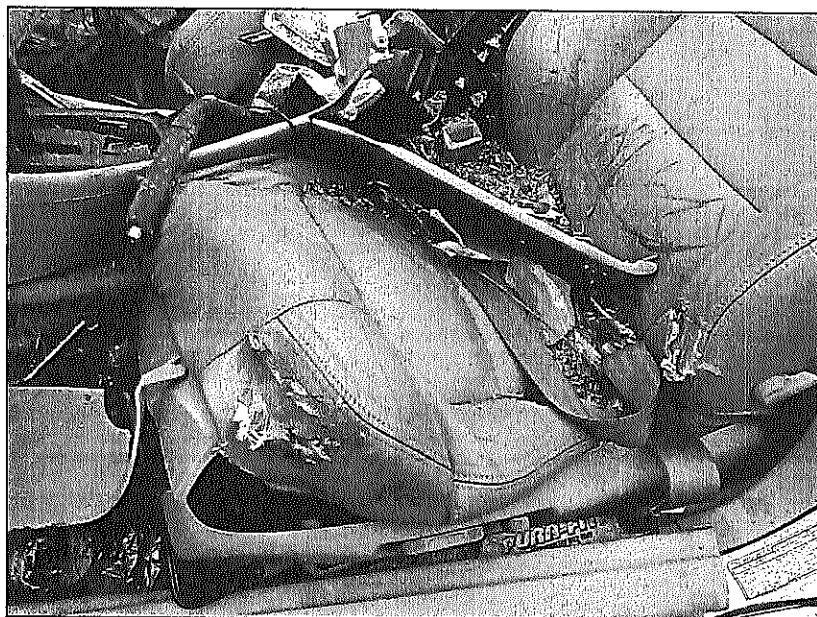
Section 1 of the webbing extended from the floor mount to the left of the driver seat. The length of the webbing from the top of the plastic housing on the floor mount to the cut end was approximately 25 inches. This section had no cupping or unusual markings (**Photograph 2**).

Photograph 2
Section 1 of the seatbelt.

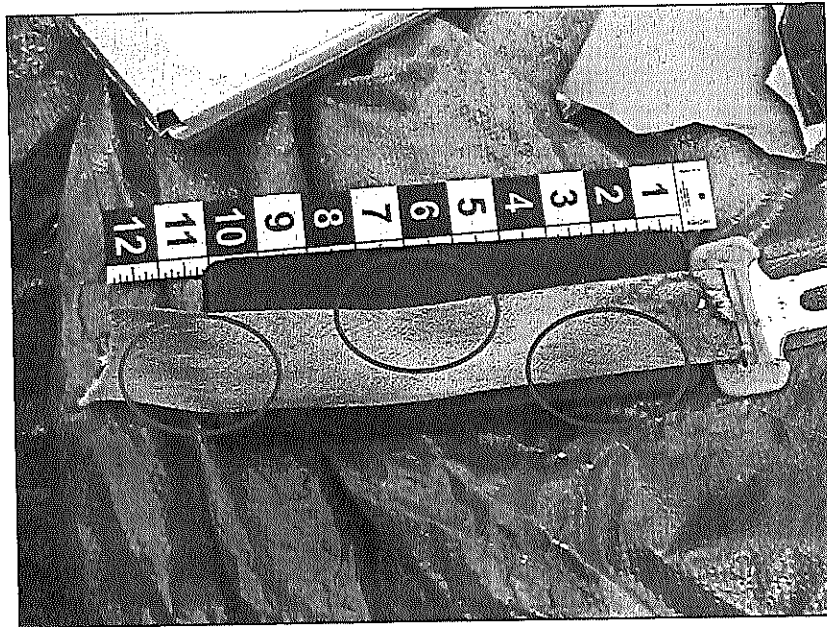
Section 2 was a cut section of webbing, approximately 17 inches in length, containing the latch. This section of webbing had cupping (**Photograph 3**). There were cuts in the webbing that appeared to be from saw cuts during extraction.

The primary direction of impact in this accident was in the lateral direction. The loading on the seatbelt webbing would not be expected to be as severe as that found in a frontal collision. However, one section of seat belt webbing had cupping. This section of webbing was the section that would have been in the buckle area during use. This cupping was consistent with loading from occupant forces during the collision and suggested that the seatbelt was being worn by the driver at the time of the collision.

If the seatbelt was not in use during the collision one would not expect this cupping.

Photograph 3
Section 2 of the seatbelt with latch, showing cupping.

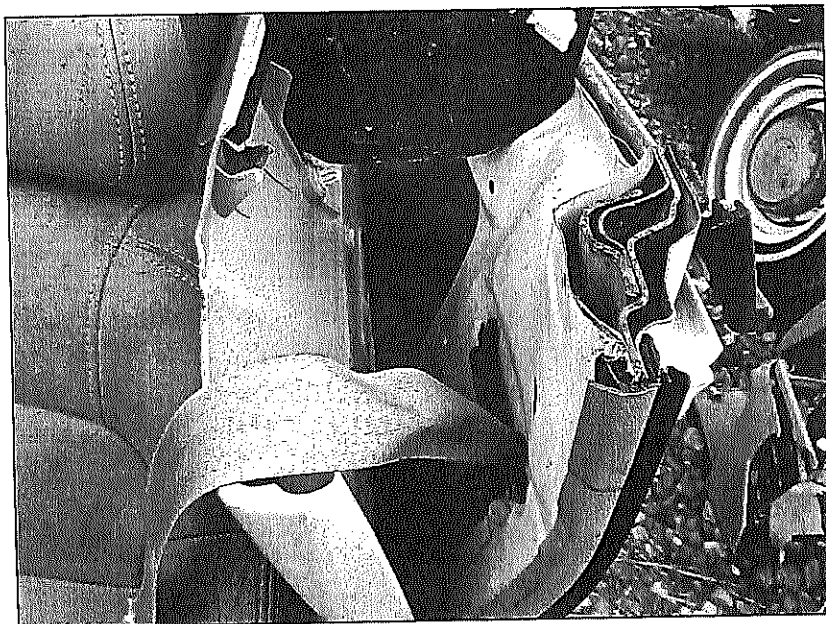
Section 3 of the webbing extended from the cut end into the seatbelt retractor. The length of the remainder of the belt fully extended from the retractor to the cut end was 66.5 inches long. This section had no cupping or unusual markings (**Photograph 4**).

Photograph 4
Section 3 of the seat belt.

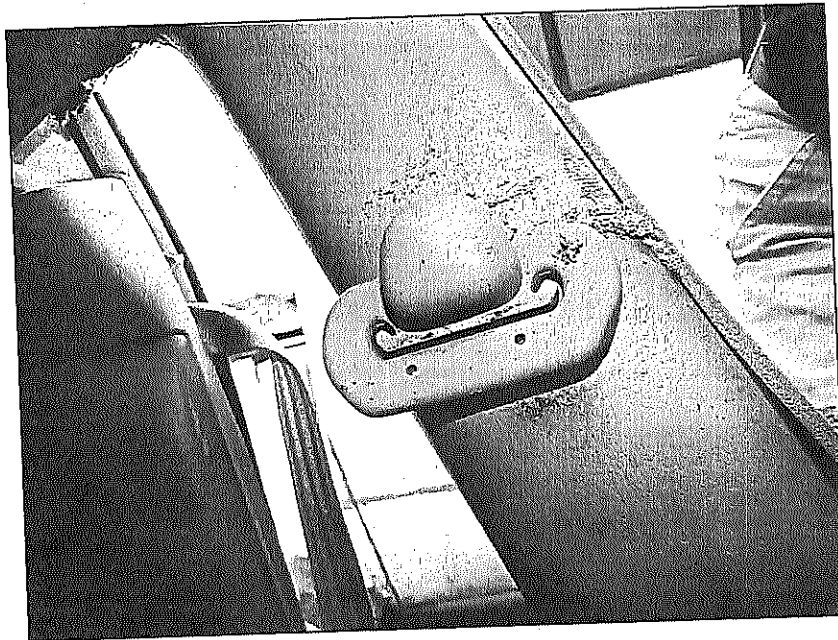
There was no damage visible on the seatbelt buckle (**Photograph 5**). The buckle functioned properly with the latch inserted. The buckle released the latch when pressed. Section 3 of the webbing contained within the retractor had no damage. The retractor functioned properly. There was superficial damage to the plastic pillar mount of the seatbelt that was consistent with sawing during the roof removal process (**Photograph 6**). There was no friction melting on the plastic D-ring.

Photograph 5
Seatbelt shoulder webbing guide.

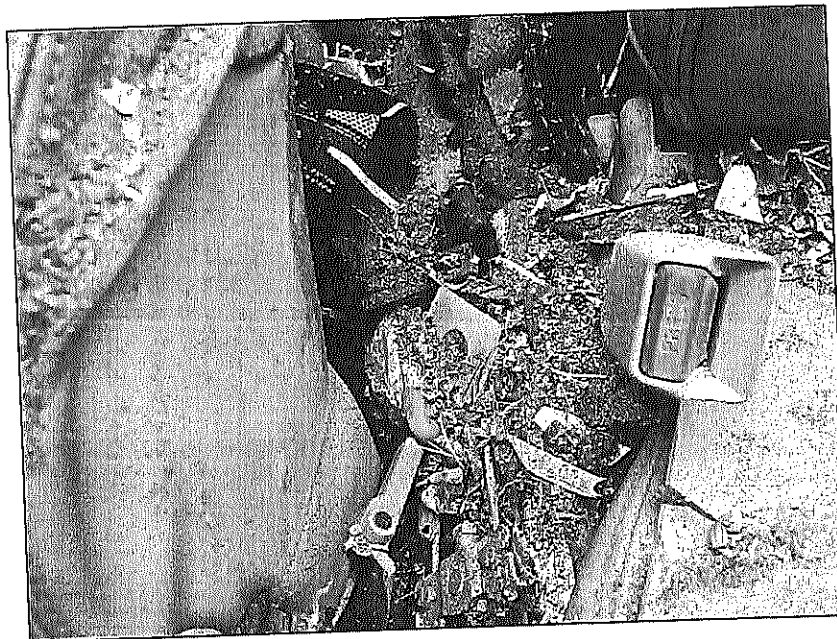
Photograph 6
Seatbelt buckle.
